Test Report

Report No. **MTS-18448 SG**
Issue Date 21/07/2014
Test Date 13/06/2014

MTS Metallurgical Testing Services was engaged to perform load tests on a toughened glass pool fence panel in general accordance with the requirements of AS 1926.1 - 2012.

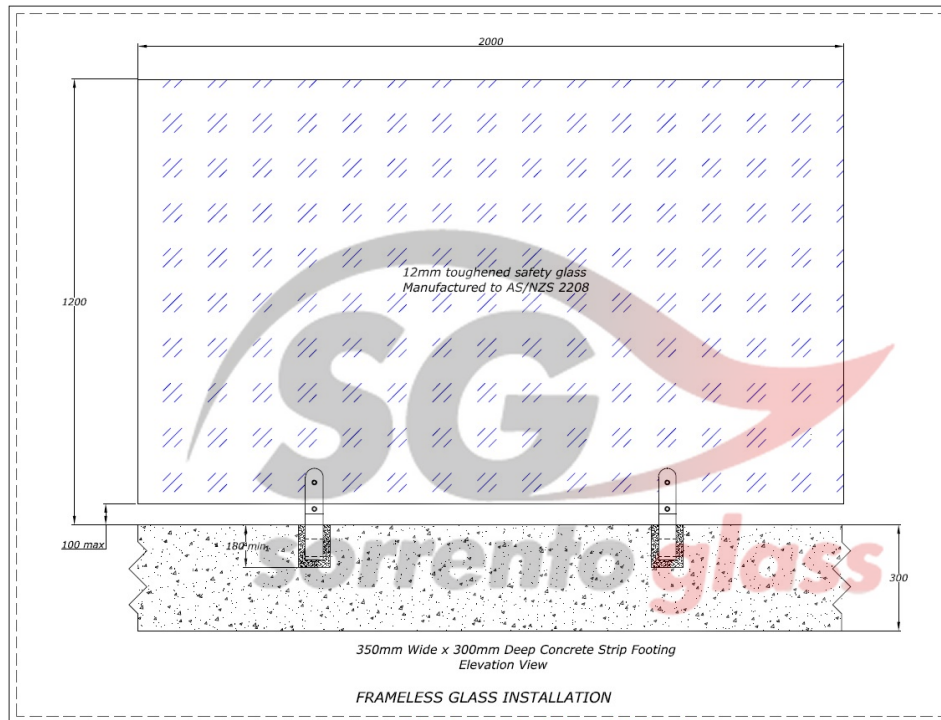
The panel was installed in accordance with the details of this drawing, modified to suit the 100mm thick floor at the test site.

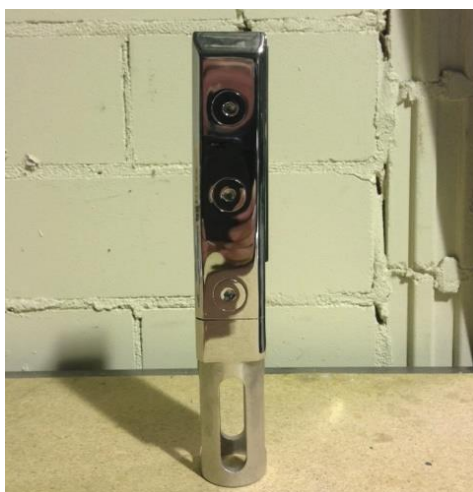
44mm Square spigot face view

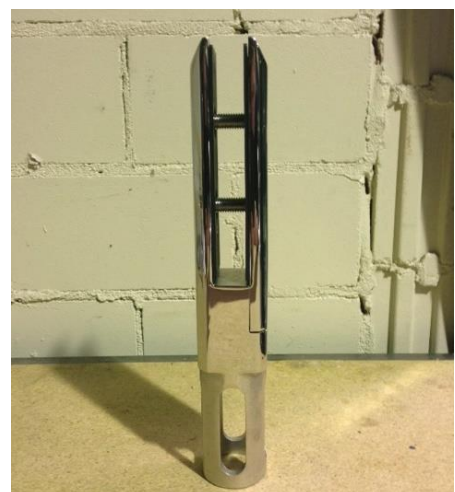
44mm Square spigot side view

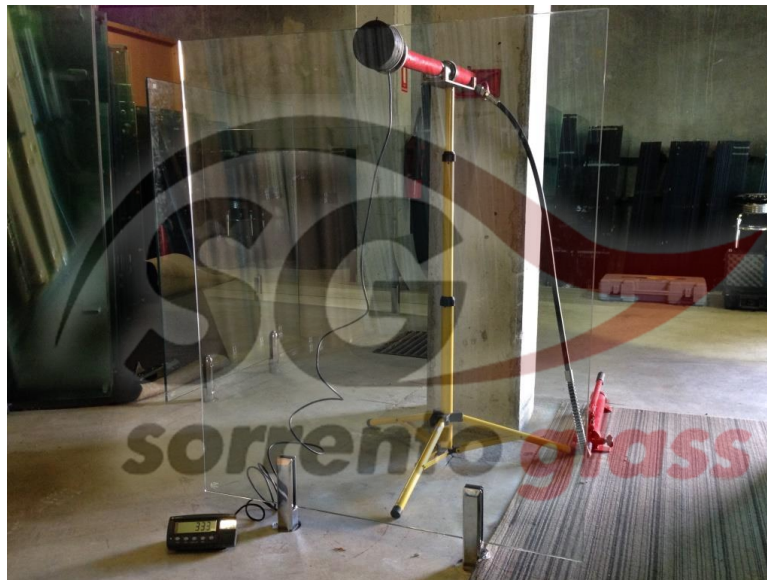
Specimen ID	Test Load (N)	Deflection Under Load (mm)	Permanent Distortion (mm)	Observations	Assessment
18448/01	330	24.0	1.5	No damage, loosening or permanent distortion	COMPLIES

The pool fence panel under test load showing the hydraulic ram and digital load indicator.
