Test Report

Report No. **MTS-18496 SG**
Issue Date 25/07/2014
Test Date 20/06/2014

MTS Metallurgical Testing Services was engaged to perform a load test on a round section semi-frameless pool fence post in general accordance with the requirements of AS 1926.1 - 2012.

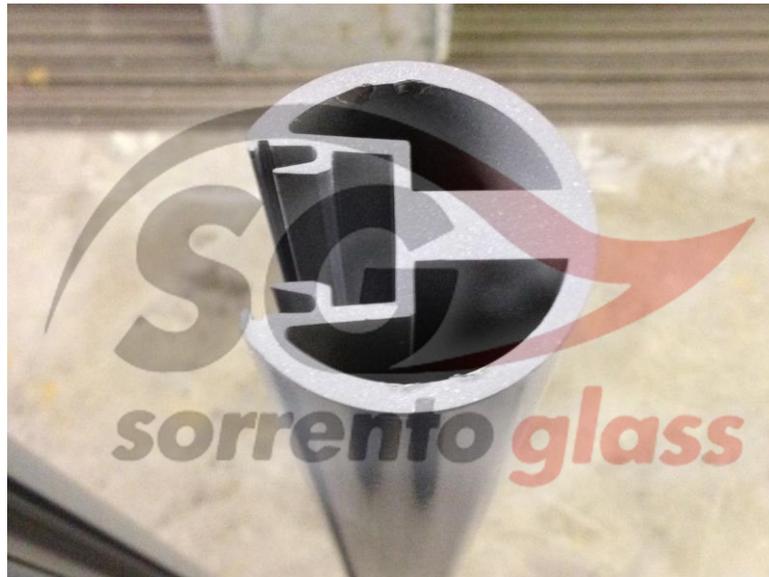
Details of the round section extrusion.

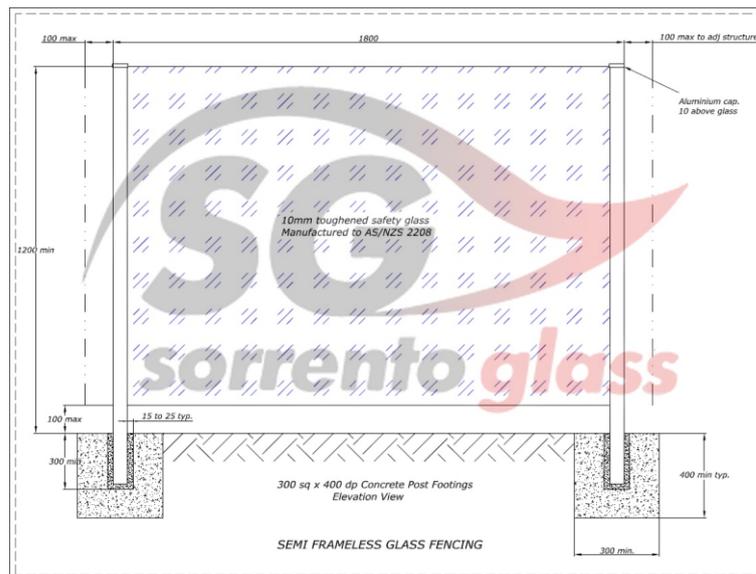
The post was installed in accordance with the details of this drawing, modified to suit the 100mm thick floor at the test site.

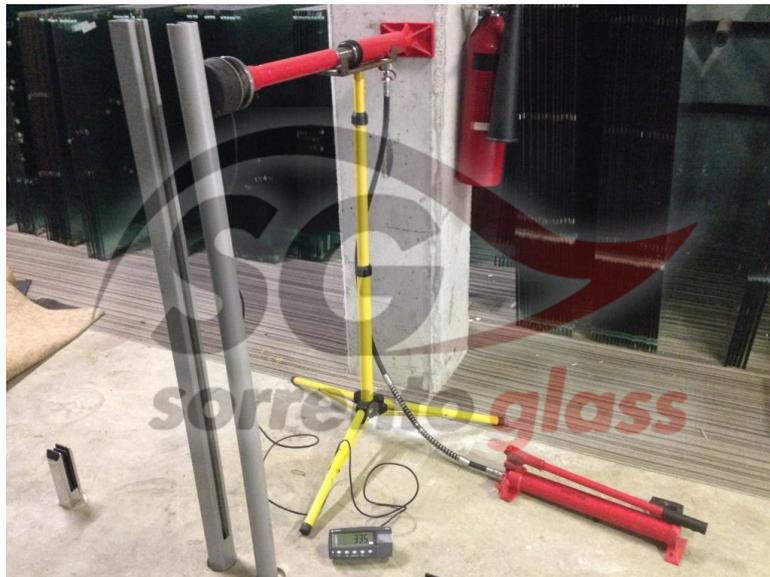
Specimen ID	Test Load (N)	Deflection Under Load (mm)	Permanent Distortion (mm)	Observations	Assessment
18496/01	330	15.5	0.0	No damage or looseness.	COMPLIES

The post under the test load showing the hydraulic ram and digital load indicator.
