Test Report

Report No. **MTS-18494 SG**
Issue Date 4/08/2014
Test Date 20/06/2014

MTS Metallurgical Testing Services was engaged to conduct a load test on a pool fence spigot to the requirements of Australian Standard AS1926.1 - 2012.

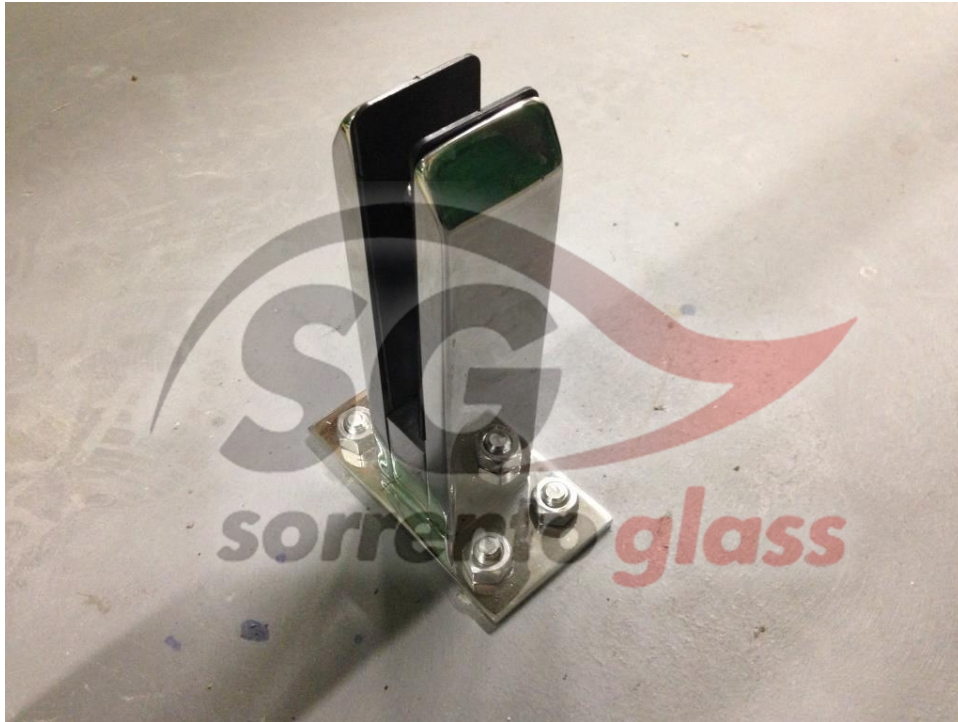
The 50mm Square Bolted Base Spigot

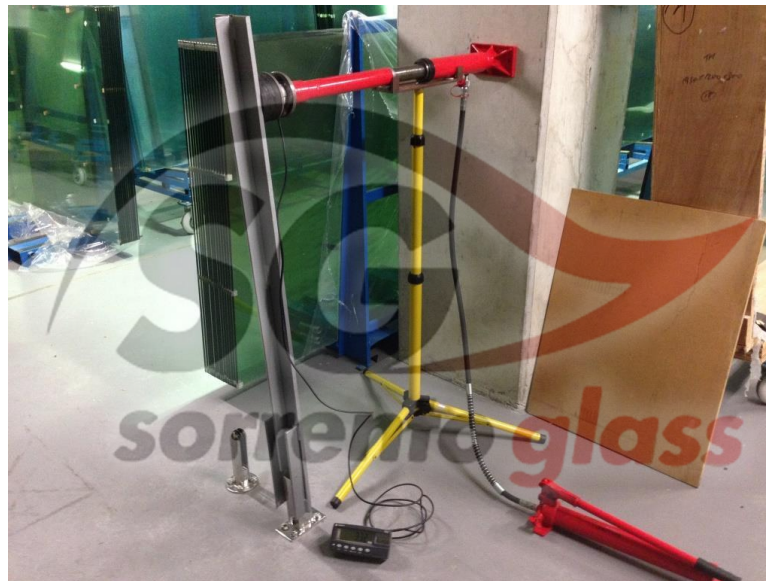
Specimen ID	Test Load (N)	Deflection Under Load (mm)	Permanent Distortion (mm)	Observations	Assessment
18494/01	330	30.0	2.0	No damage or loosening evident.	COMPLIES

The Bolted Base Square Spigot under test load.

No breakage or signs of fracture or loosening of any part. Maximum Permanent Distortion: 6mm.
 A specially made stiffened test jig was used to simulate the effect of an in-service load applied at 1200mm above ground level.
