Test Report

Report No. **MTS-18449 SG**
Issue Date 25/07/2014
Test Date 13/06/2014

MTS Metallurgical Testing Services was engaged to perform load tests on a toughened glass pool fence panel in general accordance with the requirements of AS 1926.1 - 2012.

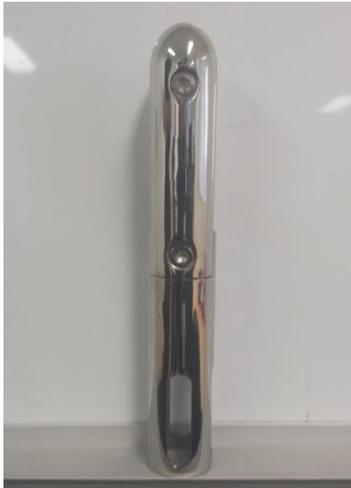
Core-drilled spigots

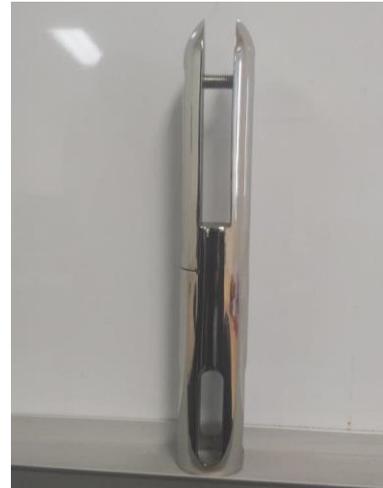
40mm Round spigot face view

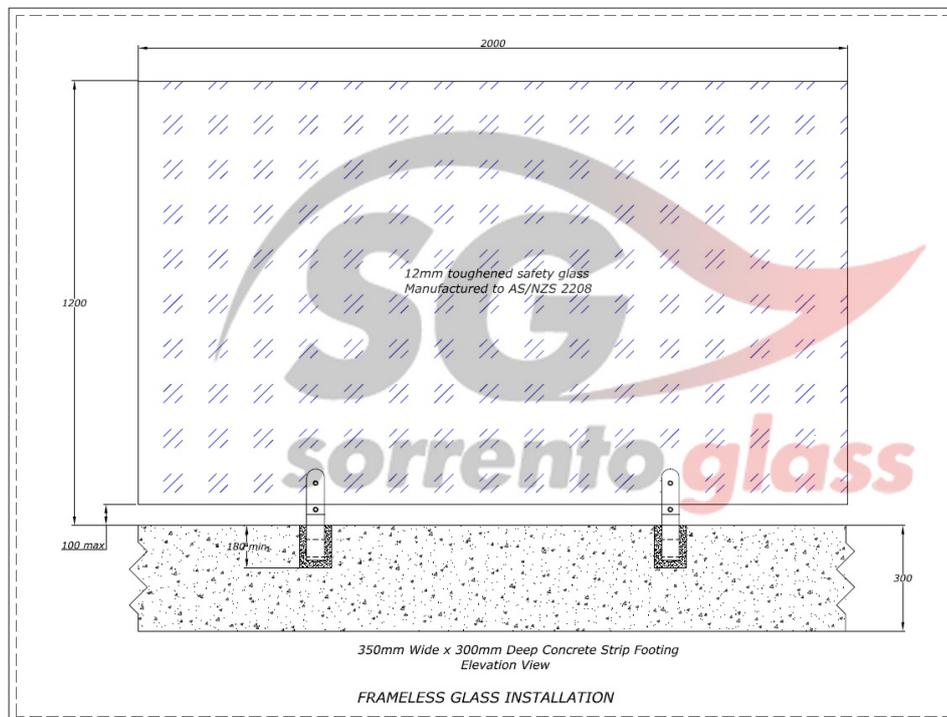
The panel was installed in accordance with the details of this drawing, modified to suit the 100mm thick floor at the test site.

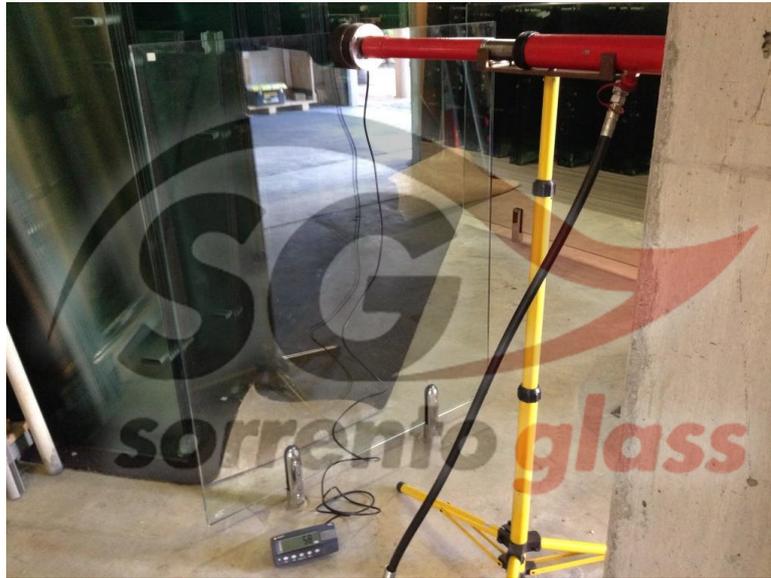
The pool fence panel under test load showing the hydraulic ram and digital load indicator.

Specimen ID	Test Load (N)	Deflection Under Load (mm)	Permanent Distortion (mm)	Observations	Assessment
18449/01	330	24.0	1.5	No damage, loosening or permanent distortion.	COMPLIES
